# SAFETY ACCIDENT REPORT

**Report on the Grounding of SV Nohea Holokai,  
Anegada, Virgin Islands  
6<sup>th</sup> July 2025**

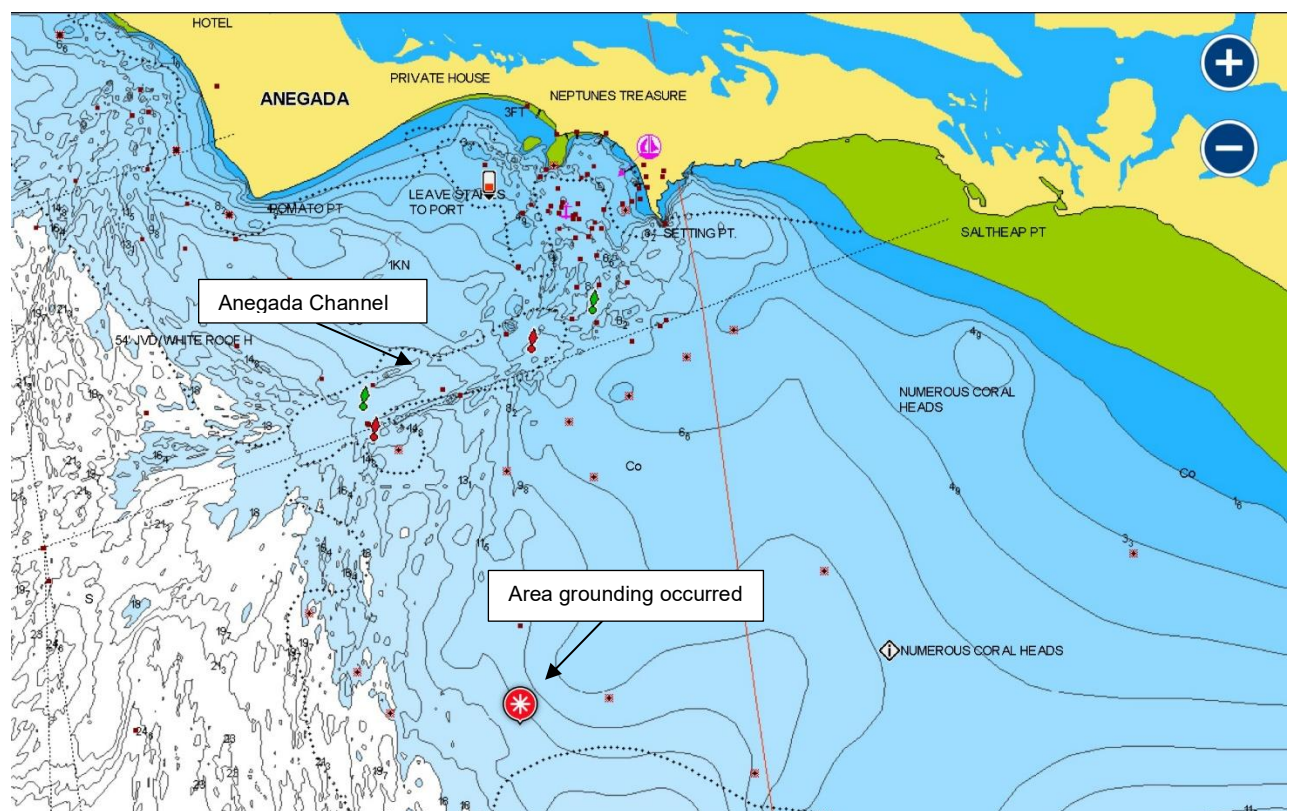
Figure 2: Navionics showing the Anegada channel and area of impact

After exiting the channel, SV *Nohea Holokai* turned to port and headed into the wind and commenced raising the mainsail. As the crew's attention remained focused on hoisting the sails, the vessel held course and departed the safer navigable track. The vessel subsequently entered the coral head field located at the port side of the channel and struck a submerged rock within the coral head field.

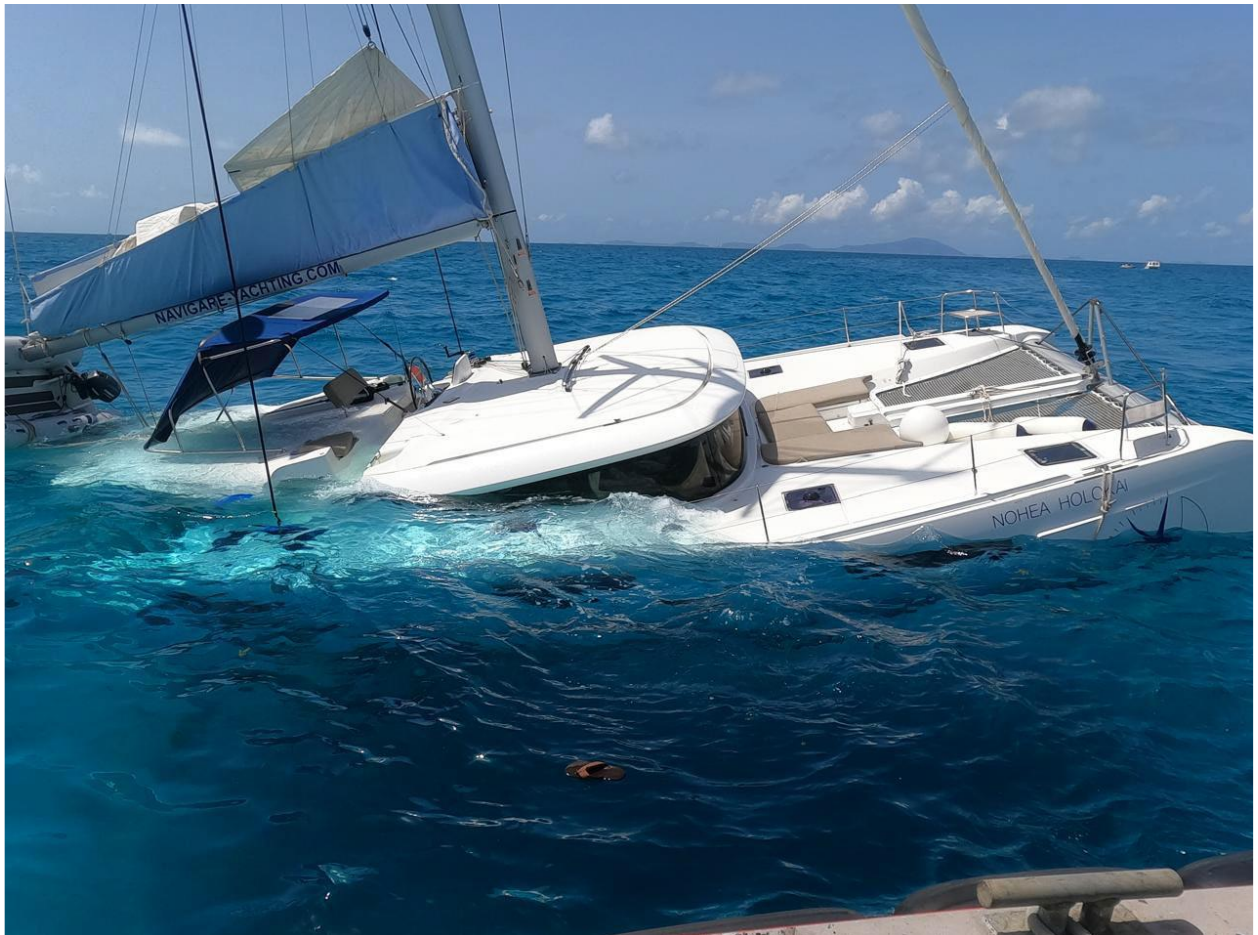
Figure 3: SV Nohea Holokai partially submerged

Following the evacuation of all persons on board, SV Nohea Holokai continued taking on water and subsequently became partially submerged and adrift south of Anegada. Husky Salvage and Towing responded with specialised salvage vessels and crew. Upon arrival on scene, the vessel was observed submerged by the stern and listing to starboard, with only the bow and sections of the bridge deck remaining above water.

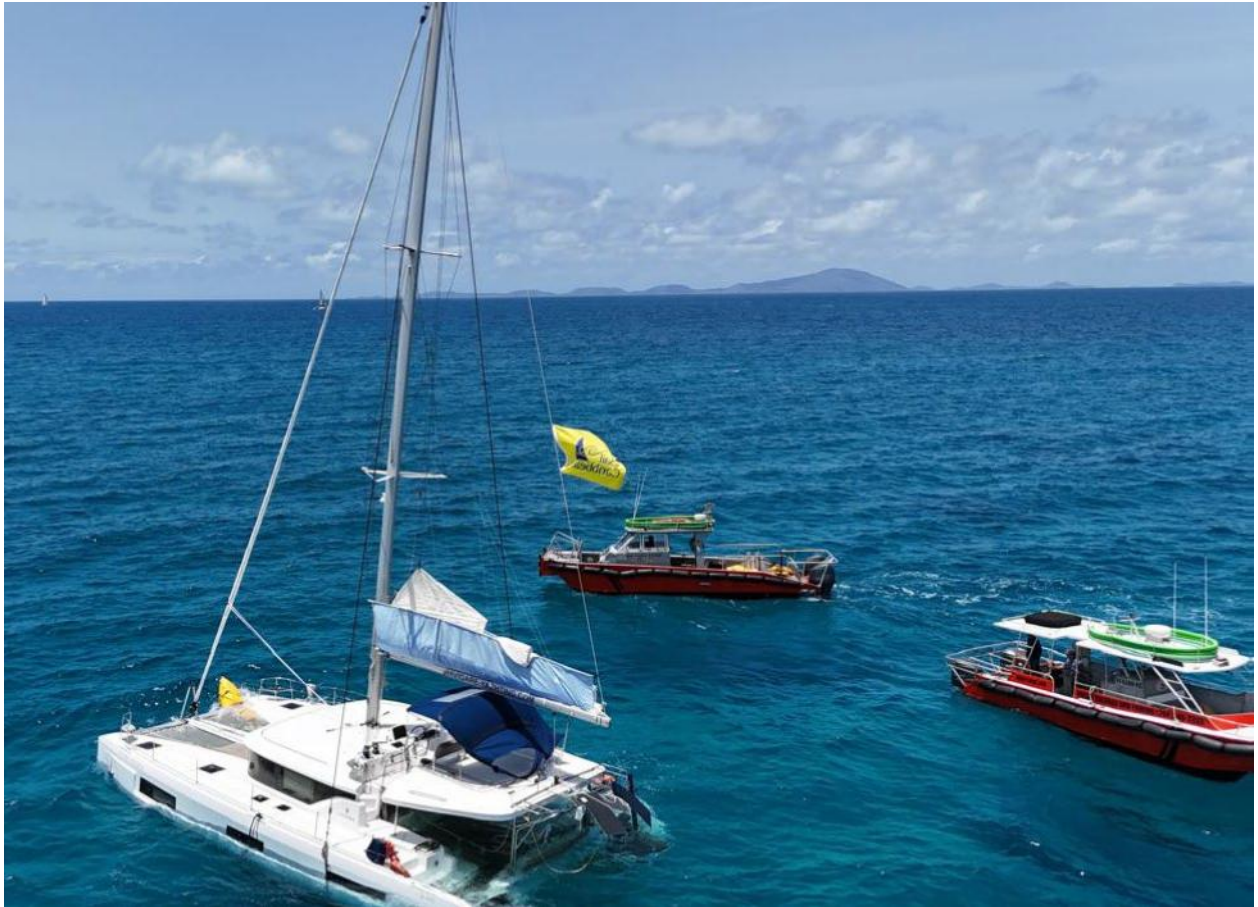
Figure 4: Husky Salvage floating the submerged vessel

Salvage personnel prioritised stabilising the vessel to prevent further sinking or rollover. Marine salvage airbags were deployed beneath the bridge deck and inflated to raise and support the stern section, while the vessel's anchor was deployed to maintain position. During the operation, responders identified a three-inch hole in the starboard hull forward of the keel, which was temporarily plugged to reduce further water ingress.

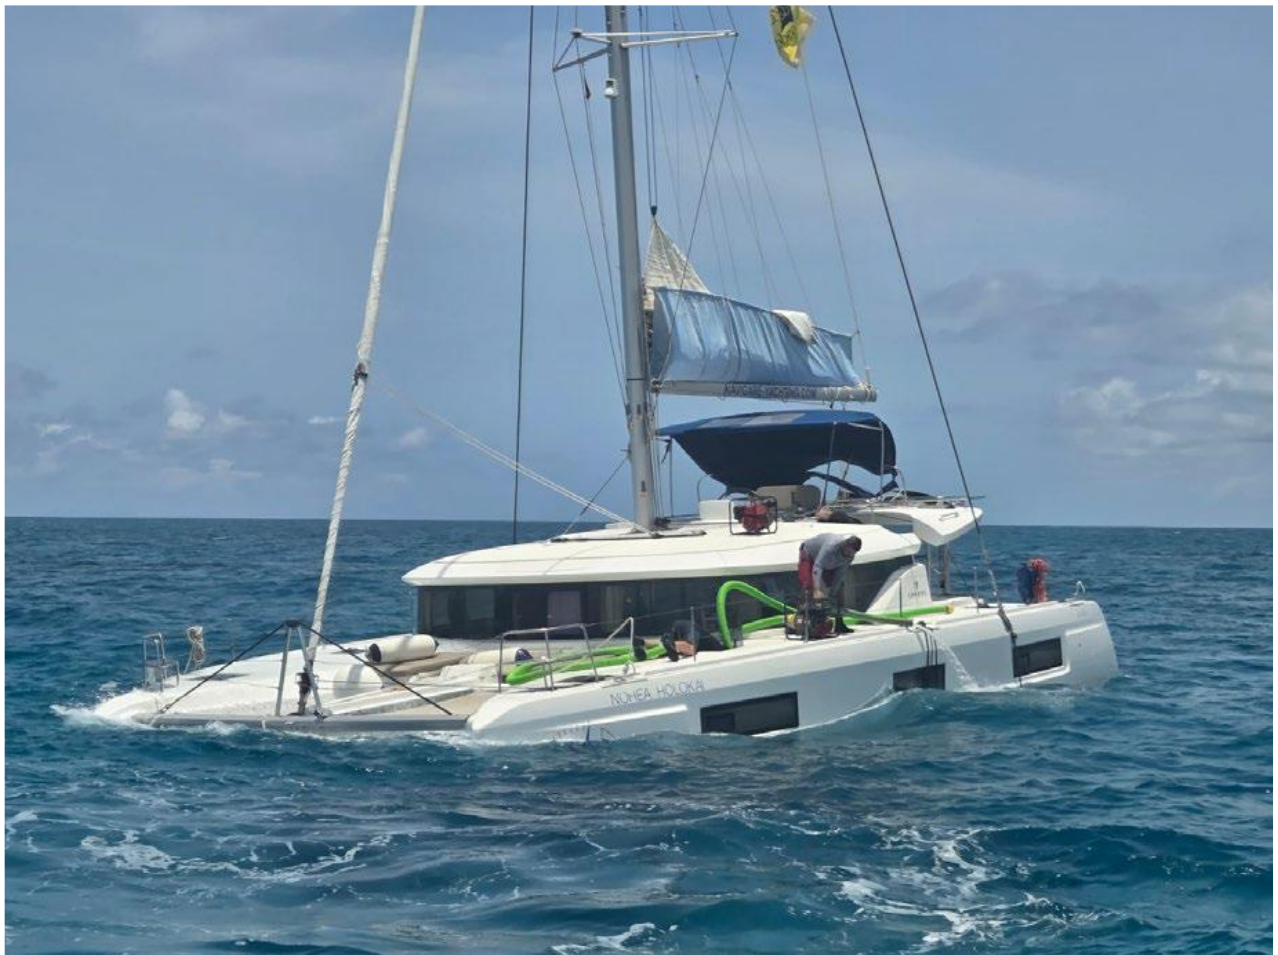
Figure 5: Dewatering and Lifting Process

Additional lift bags and dewatering pumps were subsequently used to progressively remove water from the vessel's interior spaces. During dewatering operations, smoke was observed within the saloon area, believed to have resulted from seawater encountering live electrical systems.

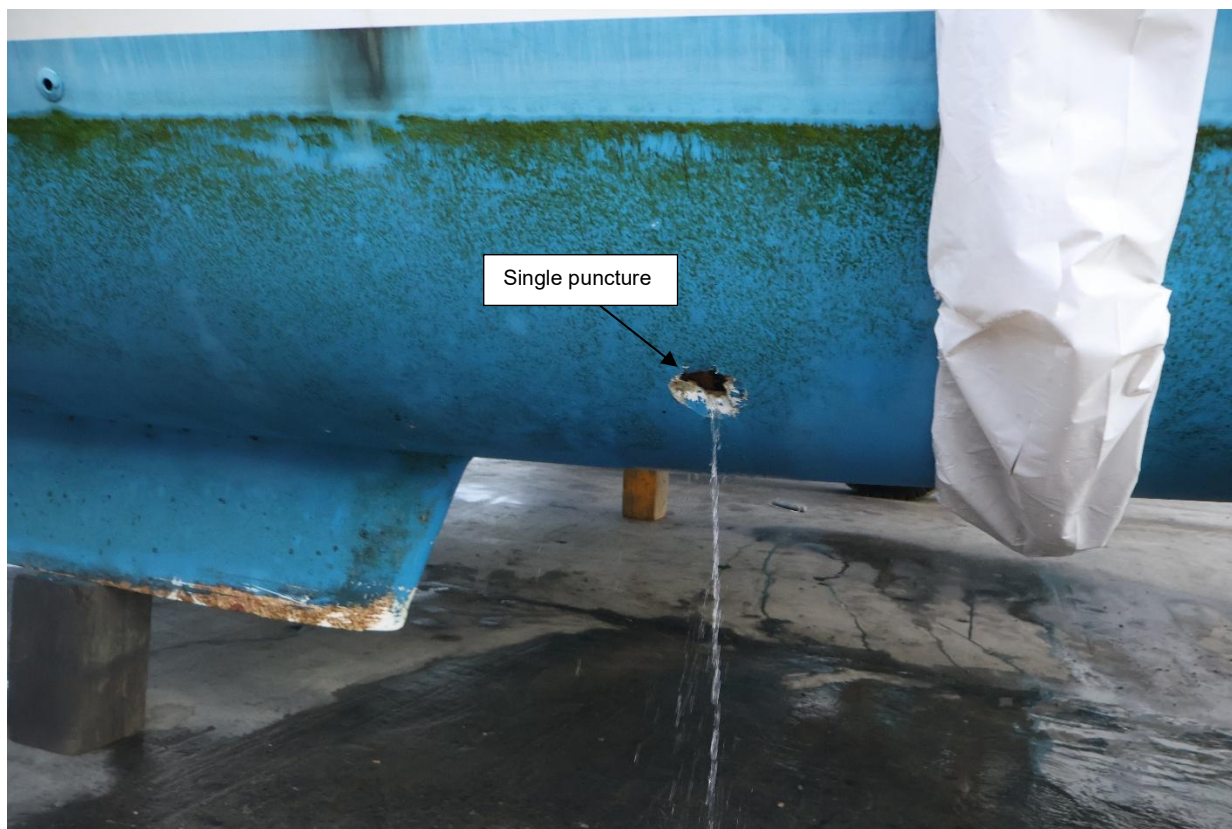
Figure 6: Single puncture observed on the starboard hull

SV Nohea Holokai was inspected at Nanny Cay Boat Yard after its recovery. During the inspection, a single puncture, measuring three inches in diameter, was found on the starboard hull below the waterline in the forward section of the vessel. Additionally, minor scraping and grazing were observed along the hull. However, the scraping was significantly less than what is typically observed with conventional grounding. The puncture indicates that there was brief, isolated contact with a rock or coral reef head.

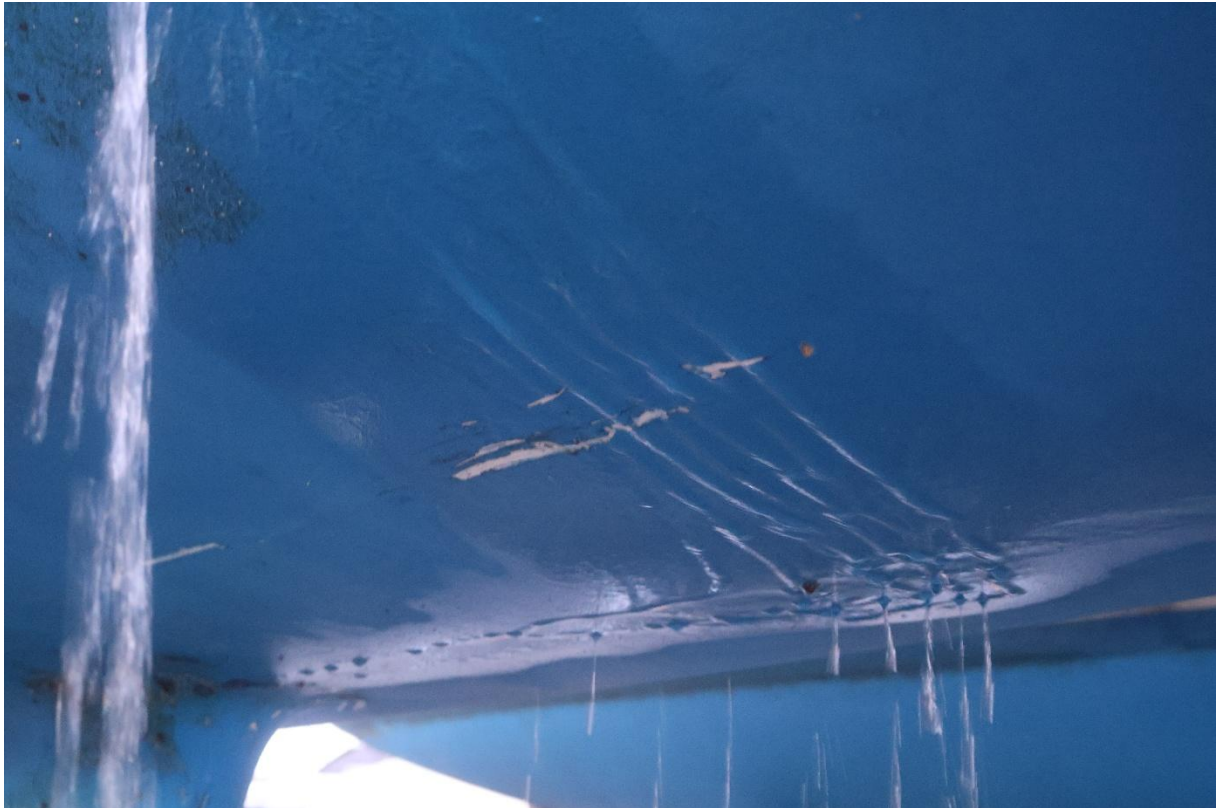
Figure 7: Light grazing observed along hull

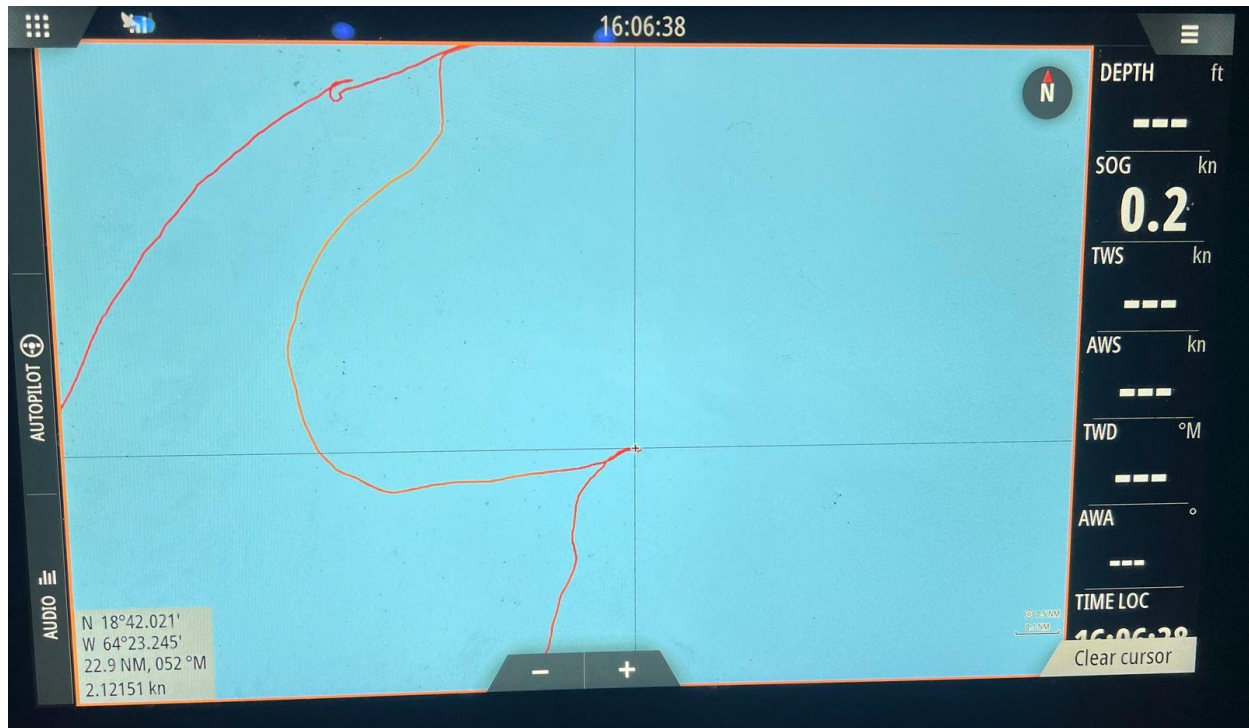
Figure 8: SV Nohea Holokai Chart Plotter display observed following the grounding

SV Nohea Holokai was fitted with a B&G electronic chart plotter. Evidence obtained during the investigation indicated that, at the time of the occurrence, the unit was not displaying the detailed chart information necessary for safe navigation through the area. As a result, the students and crew were deprived of an important navigational aid that would ordinarily have highlighted the coral head field located to port of the vessel's intended route.

4. The vessel's chart plotter was not displaying detailed navigational information, including charted coral heads and surrounding hazards. This deprived the crew of important navigational aid and reduced their ability to maintain positional awareness while operating near the reef system.

3. Sail Caribbean should review its navigational risk management procedures to ensure that defects affecting navigational equipment are identified, assessed, and appropriately addressed before vessels are permitted to participate in operational activities where such equipment may be required for safe navigation.

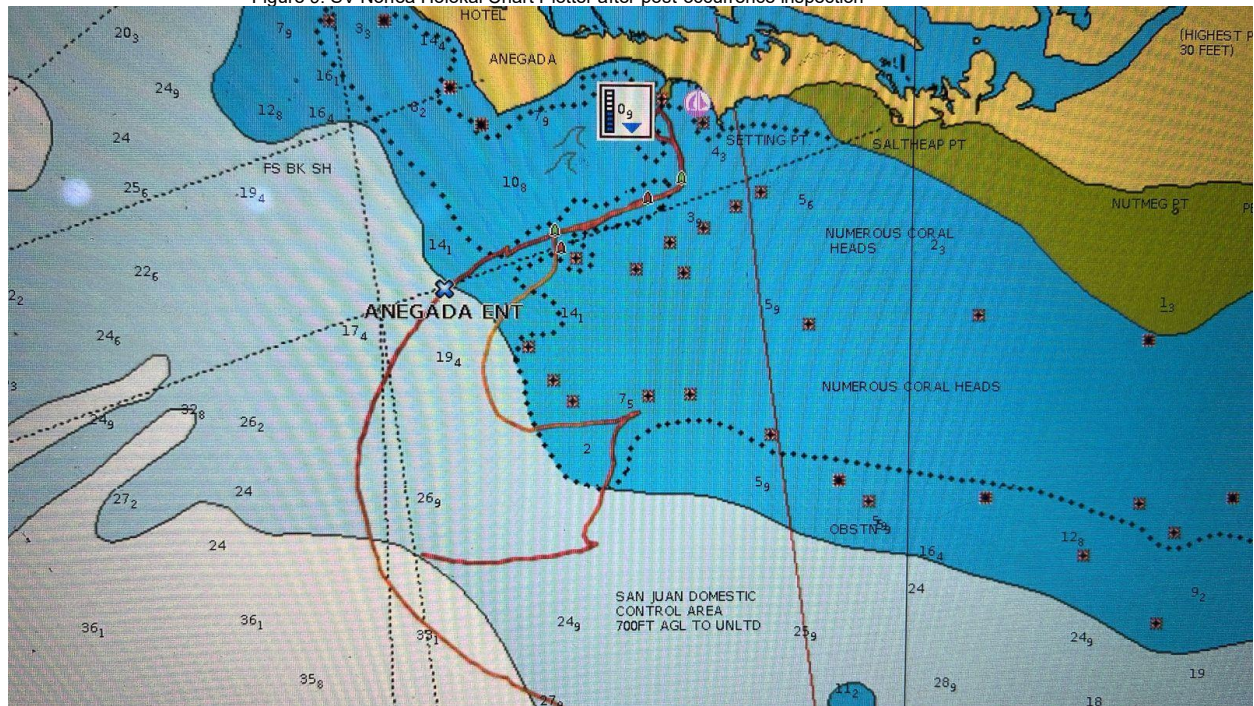
Figure 9: SV Nohea Holokai Chart Plotter after post-occurrence inspection

Subsequent examination of the chart plotter confirmed that the display was initially limited to basic mapping information. However, after the chart card was removed and inserted into an alternative card slot, the system reset and detailed chart data, including tracks, coral heads, depth contours, and channel information, became visible. This suggests that the unit was affected by a chart card or system-related fault during the voyage. Regardless of the underlying technical cause, the chart plotter did not provide the level of navigational information the crew needed during a critical phase of the passage.
